CT-based navigation systems for the thoracic spine (T1-10). Help or hindrance?

Authors: Katscher, S.; Jarvers, J.-S.; Düsing, T.;
Riesner, H.J.; Blattert, T.; Josten, C
University Hospital Leipzig, Department for Trauma
and Reconstructive Surgery

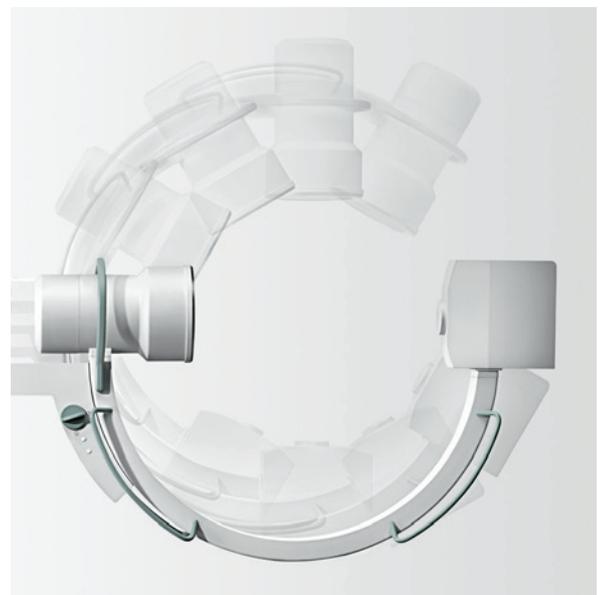
Ziehm Vision Vario 3D

These new 3D navigation techniques were tested in human cadavers (n=2) in preclinical investigations before being used in 27 patients. In these 27 patients, the reasons for stabilization were fractures (n=15), spondylodiscitis (n=5) and metastases (n=7). The anatomy where navigated dorsal instrumentation with internal fixators was used from T1 to T10. A minimum of two vertebral bodies above and below the lesion were included in stabilization in each case. In 17 cases, preoperative CT scans were used with "region based surface matching" (Vector Vision BrainLAB). In the other 10 cases, navigation was guided by intraoperative 3D scans (Ziehm Vision Vario 3D mobile C-arm). Navigated awls prepared the pedicles, the screws were inserted and final
